# Evaluation of P/M Ring Gear Using Computed Tomography and Ultrasonic Testing

*J. J. Haskins, P. Martin*

**February 22, 2001**

Lawrence  
Livermore  
National  
Laboratory

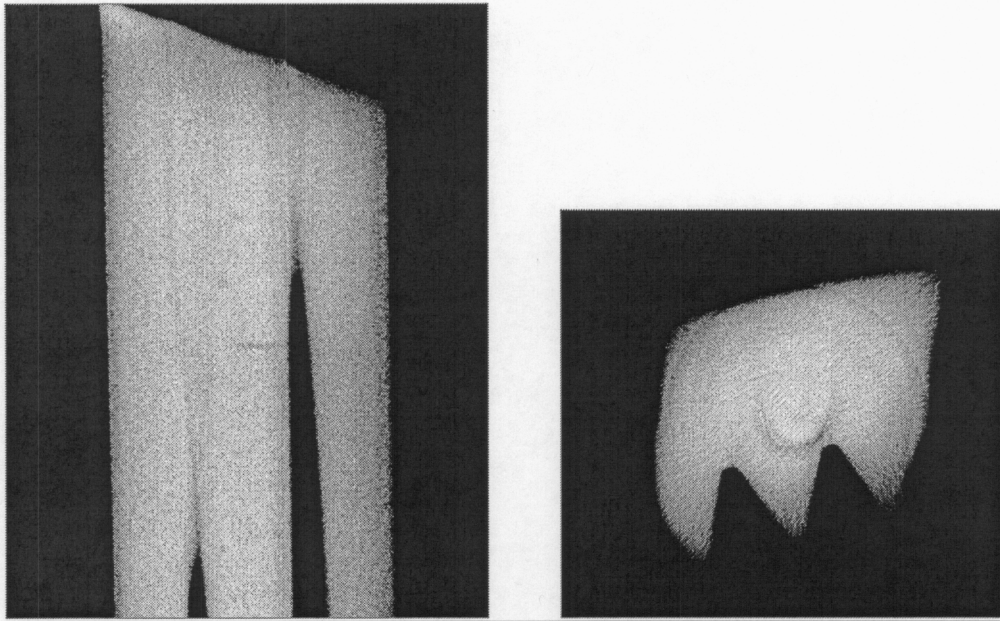
The features of concern lie at the root of the teeth and in layers along the sides of the teeth. These layers can be detected using metallography but success depends on chance and the number of sections polished. Much of the current focus is on improving the sensitivity of the CT scan and on better ways to evaluate the large data sets obtained. The initial data obtained showed anomalies close to the gear teeth as expected. Later data showed anomalies at other locations and in other orientations. Figure 3 below shows a radiograph with vertical and horizontal CT slices through regions with anomalies.

**Figure 3:** Y and Z slices through ring gear sample show large anomaly near root of tooth.

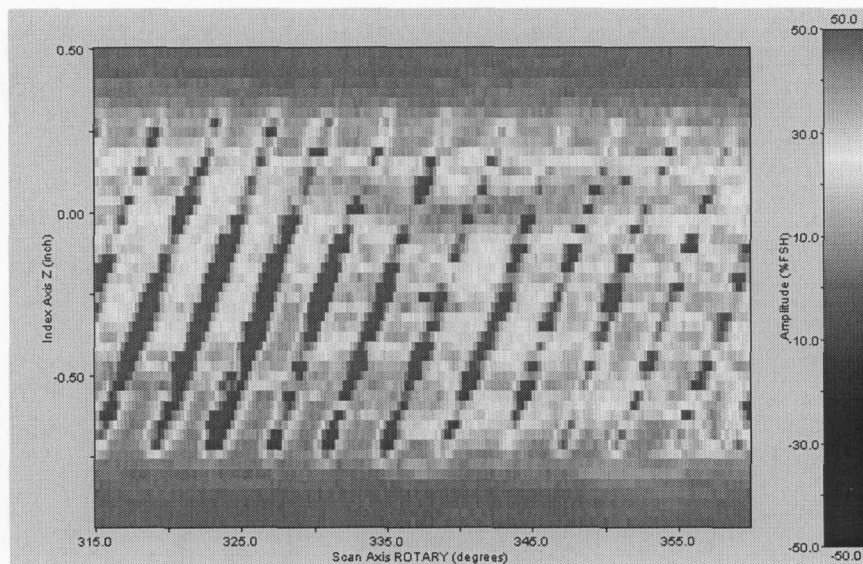
**Figure 4:** C-scan image of a 45° section of a ring gear. Color is proportional to signal amplitude. The gate is set to interrogate 6 mm below the base of the gear teeth.

Analysis of the C-scan data shows that the *approximate* dimensions of the discontinuity are 0.05” in the z-axis and 1.5° around the circumference. Given the location of the discontinuity, this corresponds to a circumferential dimension of approximately 0.07”. It should be noted that this calculation should, to be precise, account for other factors such as beam diffraction and spot size

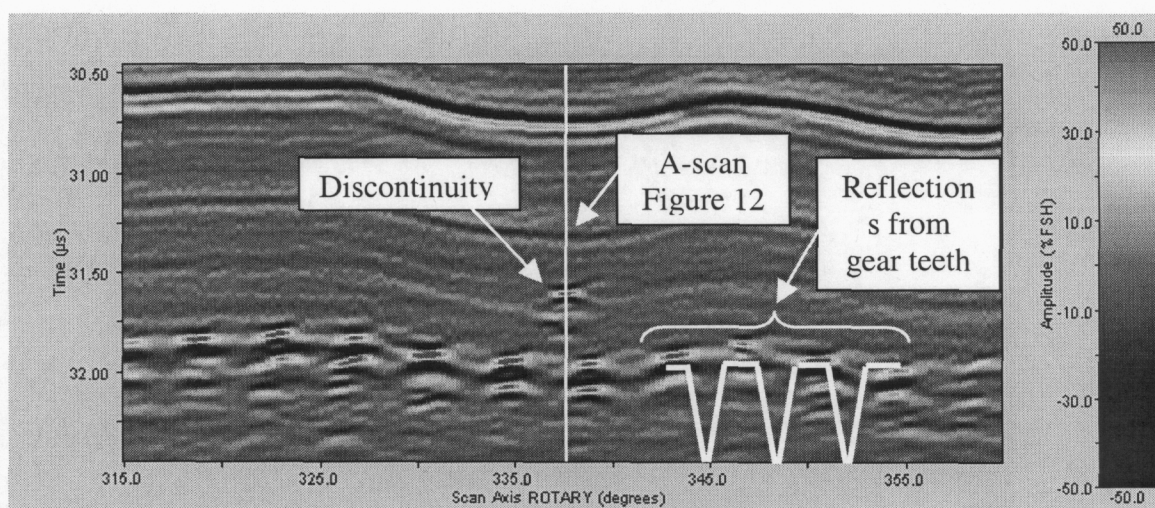
The observed discontinuity return in the B-scan in Figure 5 is a clear indication of a significant discontinuity in the part. The location of the discontinuity is slightly over 1 mm below the base of the teeth. It should be noted that these types of discontinuity were observed at various depths in the component, even near the surface. However, for the purpose of the current study, the defects of primary interest are in the region around the base of the teeth since this is the most problematic location in terms of potential gear (tooth) failure.

Note the ‘wavy’ front running across the image in Figure 5 at approximately 30.50 - 30.75  $\mu$ s. This artifact corresponds to a spurious (multiple path) echo from the front face of the specimen. Thus, while the location of the echo does not correlate to any physical feature of the component at the corresponding depth in the material, the shape (i.e. ‘waviness’) corresponds to the degree of roundness of the outside circumference of the part. The waviness in the figure corresponds to approximately 0.5 mm of surface displacement. Note that the gear tooth echoes follow the surface displacement, so the indication is not of varying thickness but rather of constant thickness and an out-of-round condition.

**Figure 5:** B-scan showing time of flight of the acoustic signal versus degrees around the ring gear (from 315-360°). Color is proportional to signal amplitude. Note the discontinuity return at ~338°. The gear

teeth are indicated schematically, and the vertical white line indicates the location of the A-scan shown in Figure 12.
